THE PLAZA HOTEL

Steel Grandeur

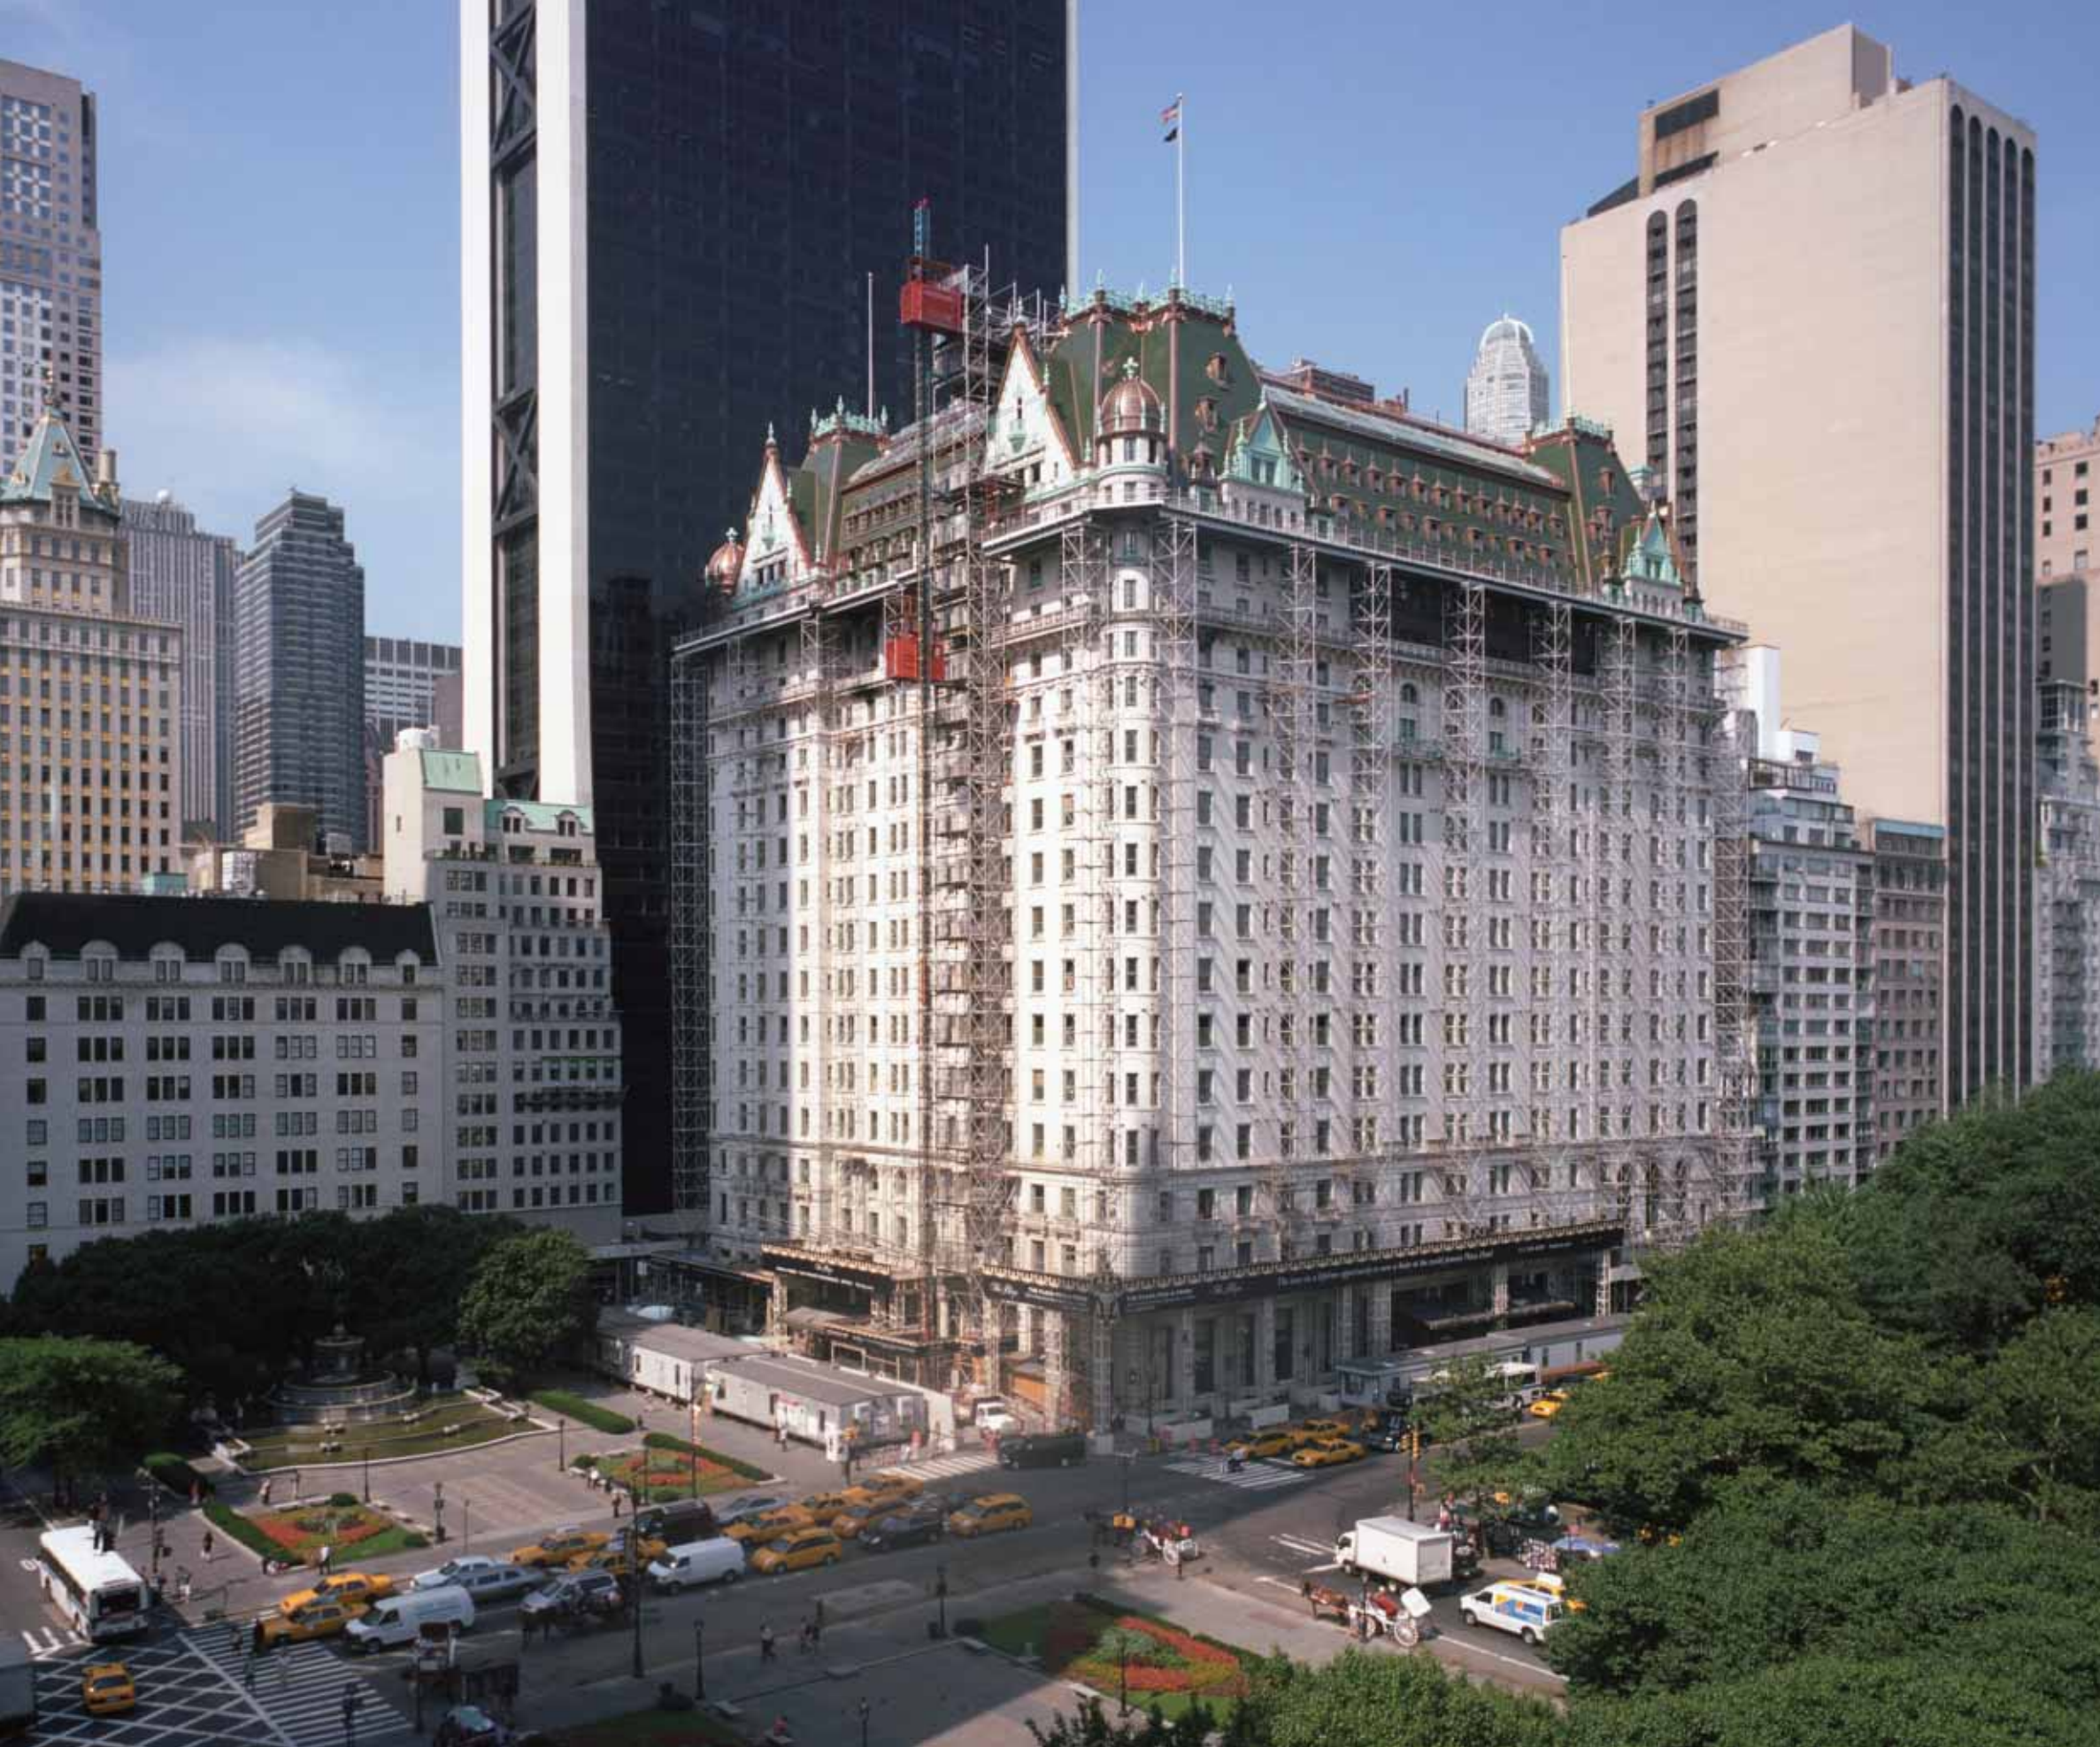
Previous The Plaza's mansard was completely replaced and a floor was added.

Opening up the new penthouse floor raised the hotel's landmarked mansard roof by 14 feet. Designed with sloping glass setbacks that take advantage of the stunning park views and maintain the roof's original sight lines, the penthouse level was added after the original roof was removed. Tishman installed temporary shelters over various sections of the building to avoid exposing the whole area to the elements for a long period. Some of the 19th floor columns had to be strengthened to accept the additional load of the 20th floor, as well as the load of new mechanical systems that were added to the roof. Some of the 19th floor was reframed in order to level the floor. The new members ranged in size from W8x15s to W24x29s. The smaller members were used for the penthouse floor's columns, whereas the larger members were used for girders from which the team hung the additional space created for the floors below.

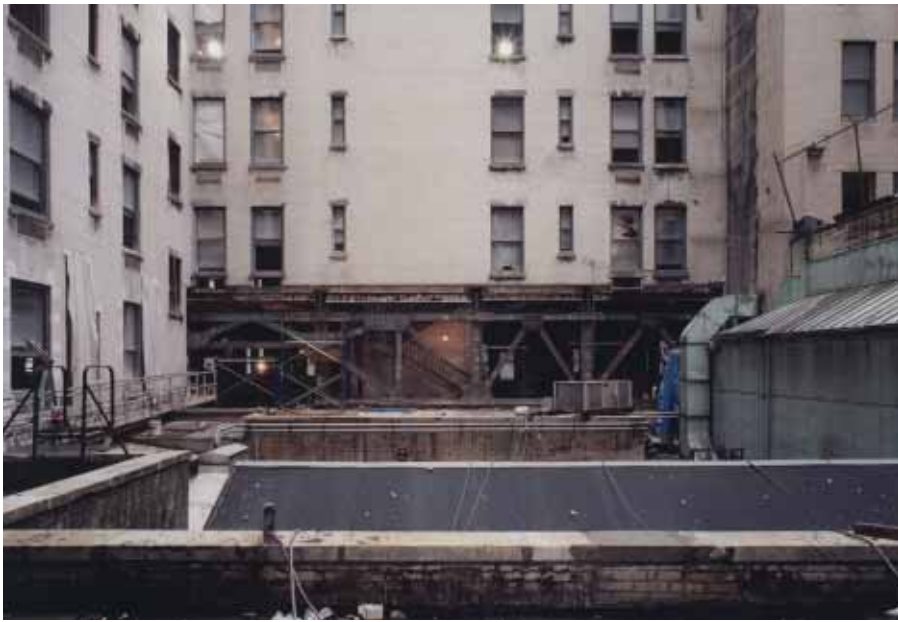
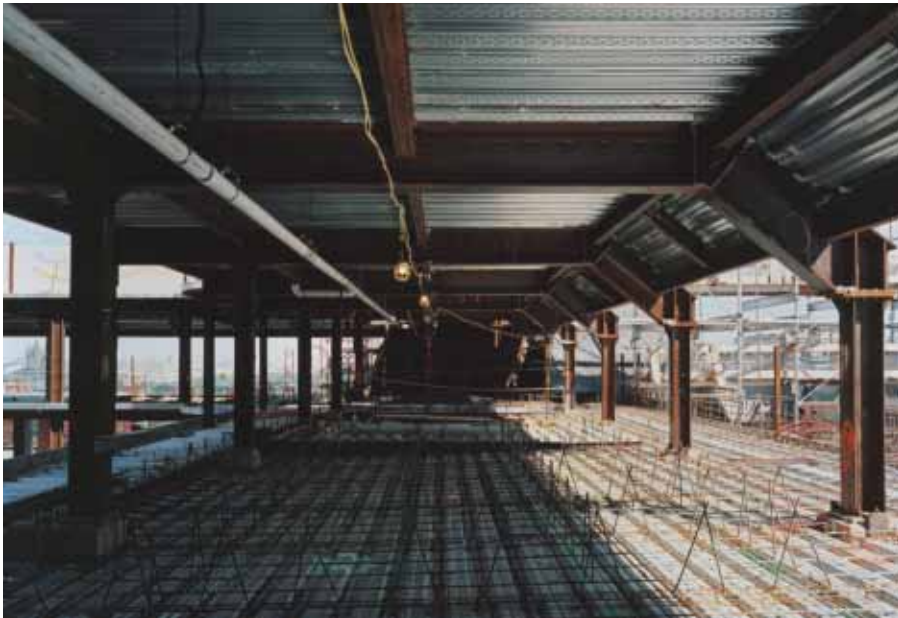
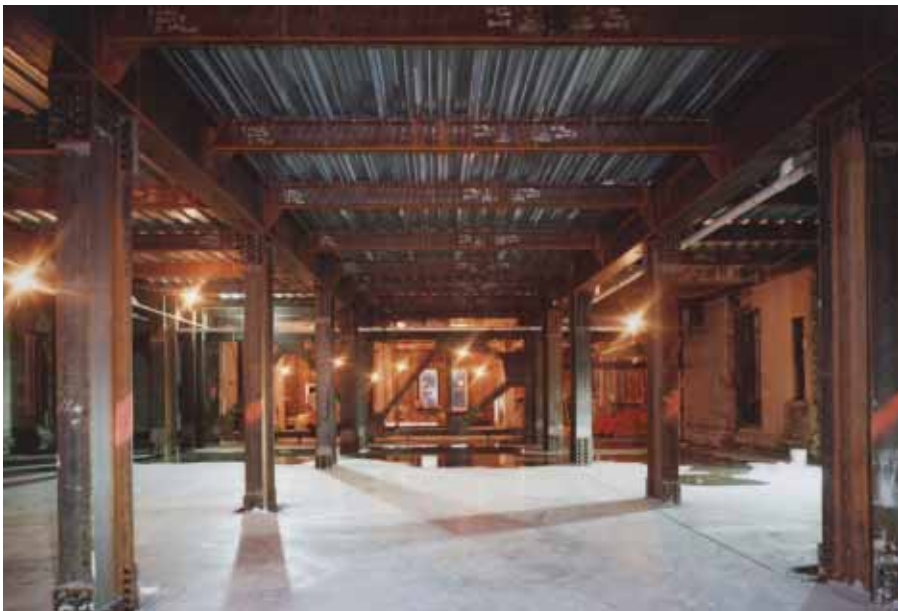
Top left and bottom right A Vierendeel truss added in the Plaza's courtyard created space for a spa and garden. **Middle and bottom left** New steel framing on the 19th and 20th floors.

Adding the new spa and garden was slightly more complicated, as the floor loads associated with these spaces had to be carried by spanning the entire courtyard to avoid dropping columns into the restored Palm Court. The engineers decided to employ Vierendeel trusses, using their rectangular openings to create useable floor space for the spa. The trusses, which measure 96 feet long and

15 feet high, are made up primarily of W27 chords and columns, though member sizes vary depending on loads, from W24x94s and W30x235s. All connections between columns and chords are bolted moment connections.

Getting these 165-ton trusses into the courtyard presented a challenge of its own. The solution devised by the team used crawler cranes to slide the top and bottom chords through the Plaza's windows on 59th Street, where cables suspended from ceiling framing picked them up and delivered them to the courtyard. Once in the courtyard, cables suspended from above held the trusses in place while ironworkers aligned, infilled the columns, and connected them to the existing structure. DCM made these connections by cutting holes in the existing built-up members, threading gusset plates through, and welding the plates to both sides of the columns. Then the trusses were bolted onto the plates. Once pinned in place the team bolted the columns into place between the chords. The operation, carried out on a weekend so that street traffic would be light, was particularly daring because extra caution was needed to protect the Palm Court from threat of damage. Before this could take place, the existing columns had to be encased down to the foundation to handle the extra loads imposed by the new spaces.

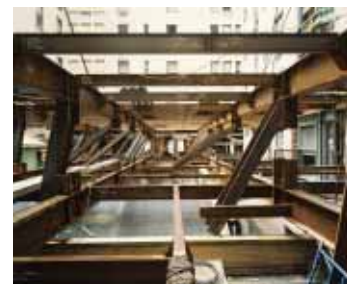
Right A sloping glass wall on the new penthouse floor maintains the Plaza's historic sightlines.
